Surveyor Spacecraft System

SURVEYOR IV FLIGHT PERFORMANCE
FINAL REPORT

JPL Contract 950056/September 1967

SSD 68189-4

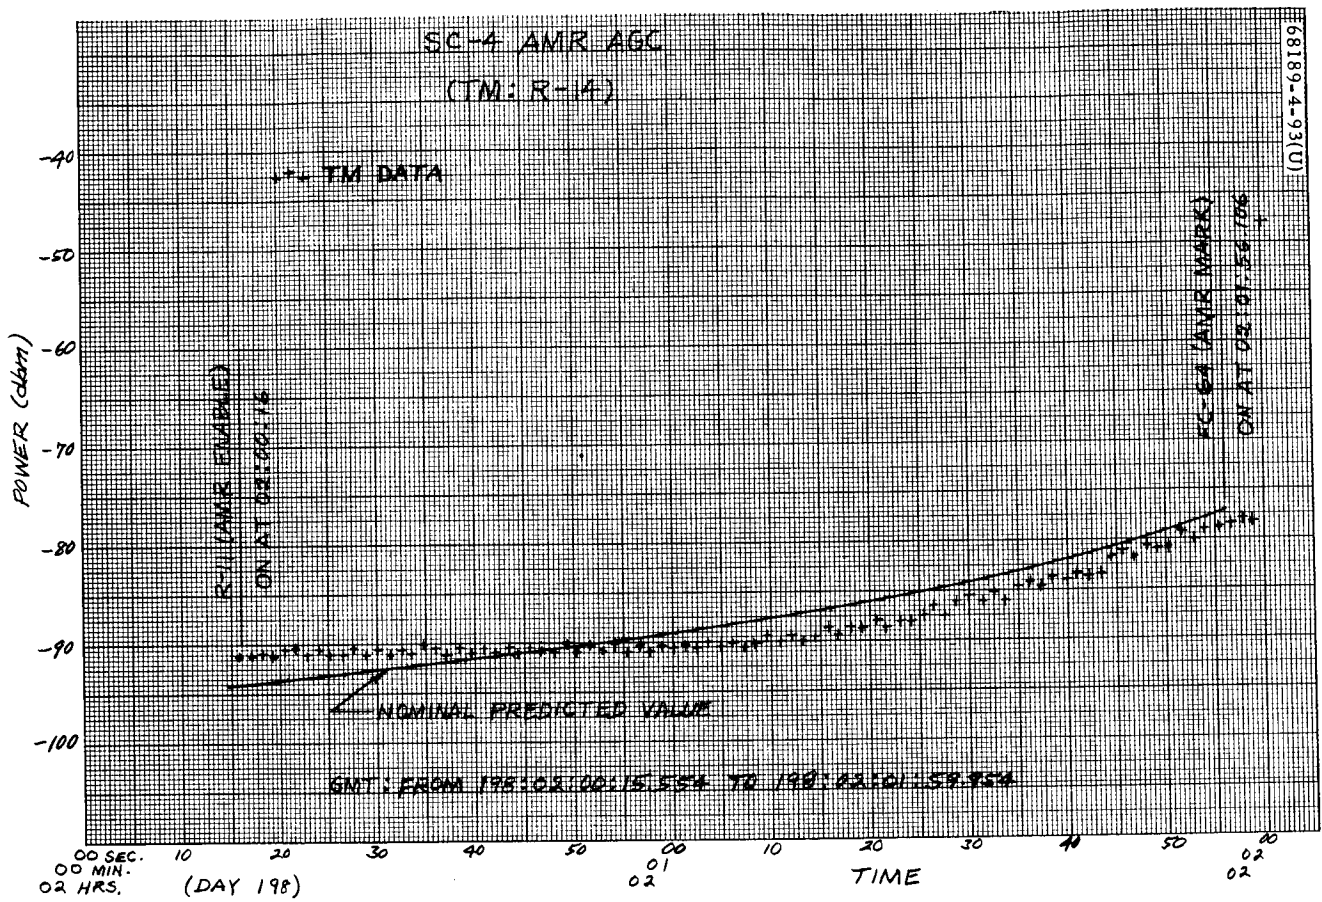
Concerning the trajectory reconstruction for AGC evaluation, the total stretched pulse length as received was about 20.8 microseconds and the effective closing rate was 8597 fps, both at the time of mark. The corresponding video pulse closing rate was therefore about 17.5 microseconds per second. The nominal video late gate is 20 microseconds (20 ± 1 , required). It should therefore have produced output within 3 db of peak for $(20.8 + 20.0) / 17.5 = 2.33$ seconds, ensuring that one of the samples at 1.2-second (mode 6)

Figure 5.8-1. Surveyor IV AMR AGC

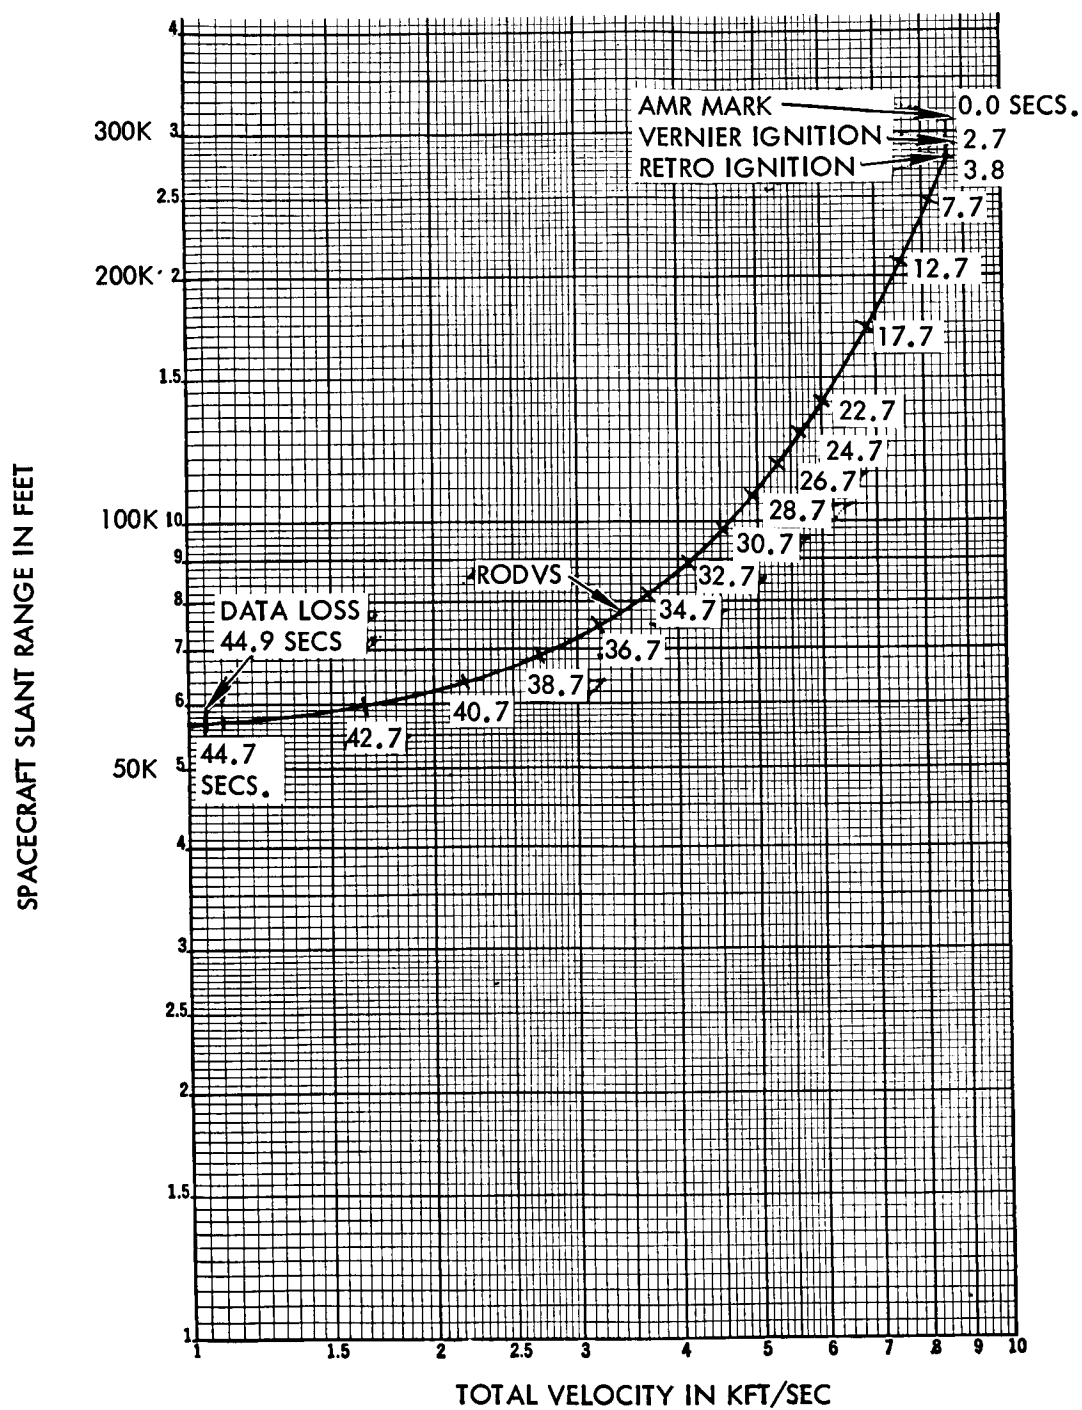
Figure 5.9-1. Six Degree-of-Freedom Program Predicted Trajectory

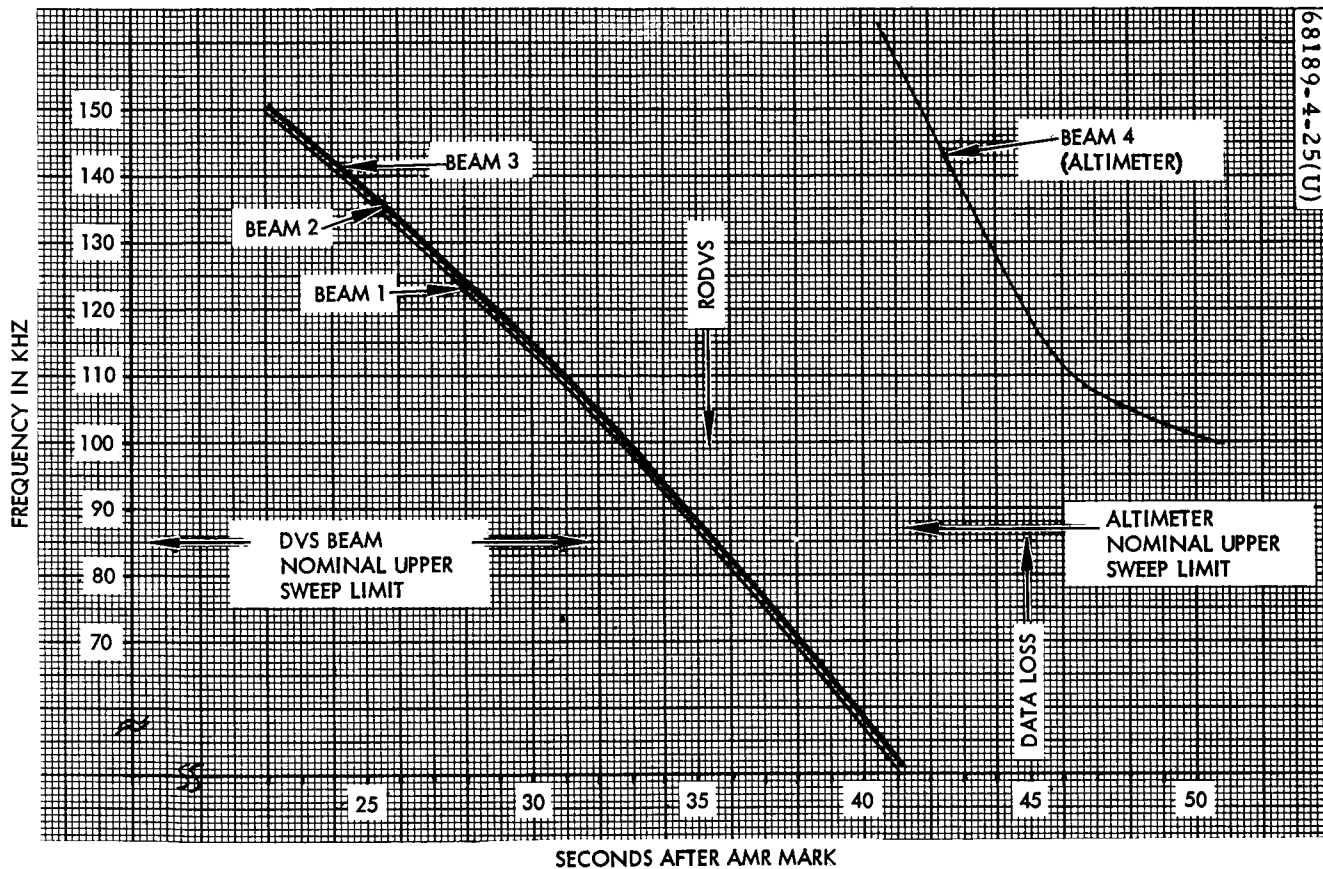
Figure 5.9-3 shows the predicted values versus time (in the region of interest) of the signal frequencies on all four RADVS beams.

Figure 5.9-3. Preflight RADVS Predictions (Six Degree-of-Freedom Program)

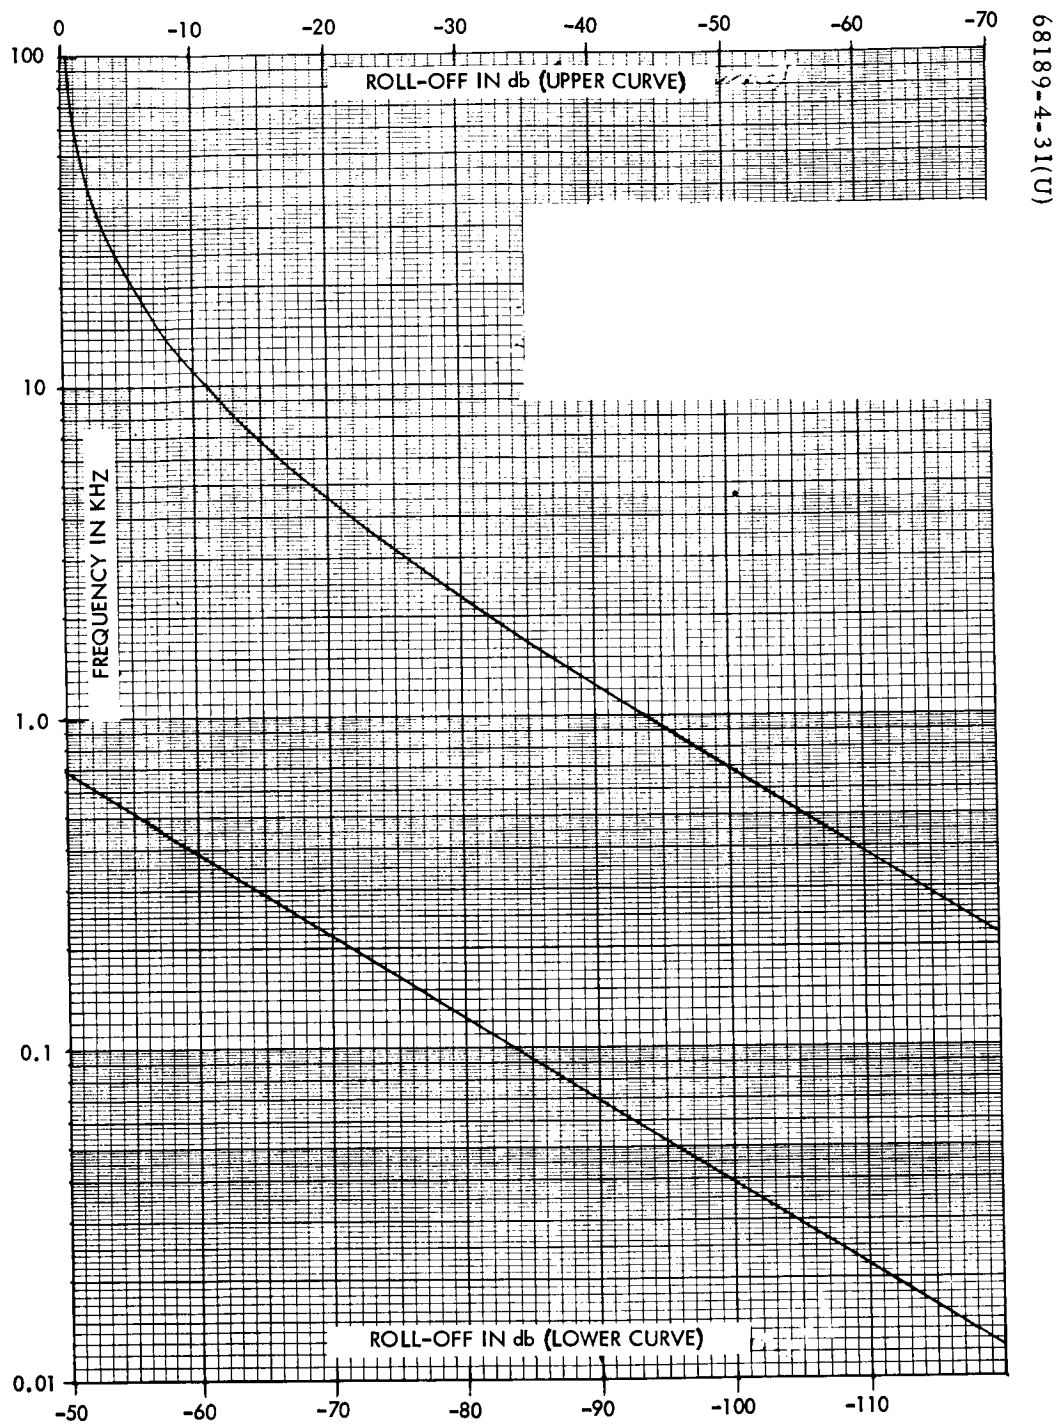
Figure A-1. A-21 RADVS Radar Altimeter (Beam 4) Nominal Roll-Off

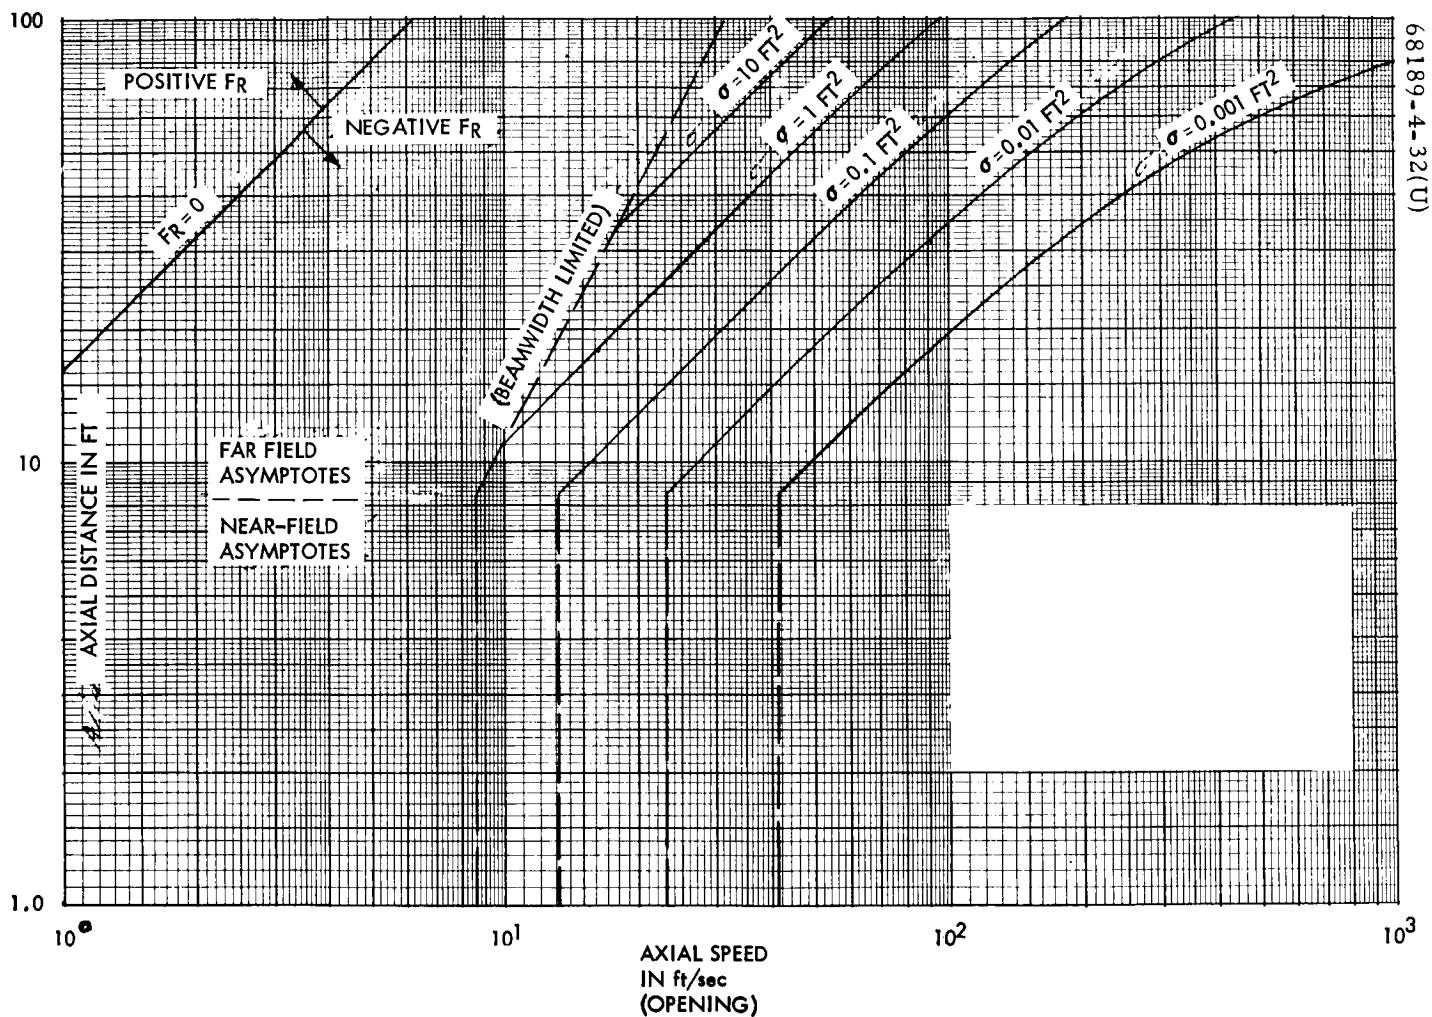
Figure A-2. Surveyor III RADVS Radar Altimeter (Beam 4) Asymptotic Contours of Range and Velocity

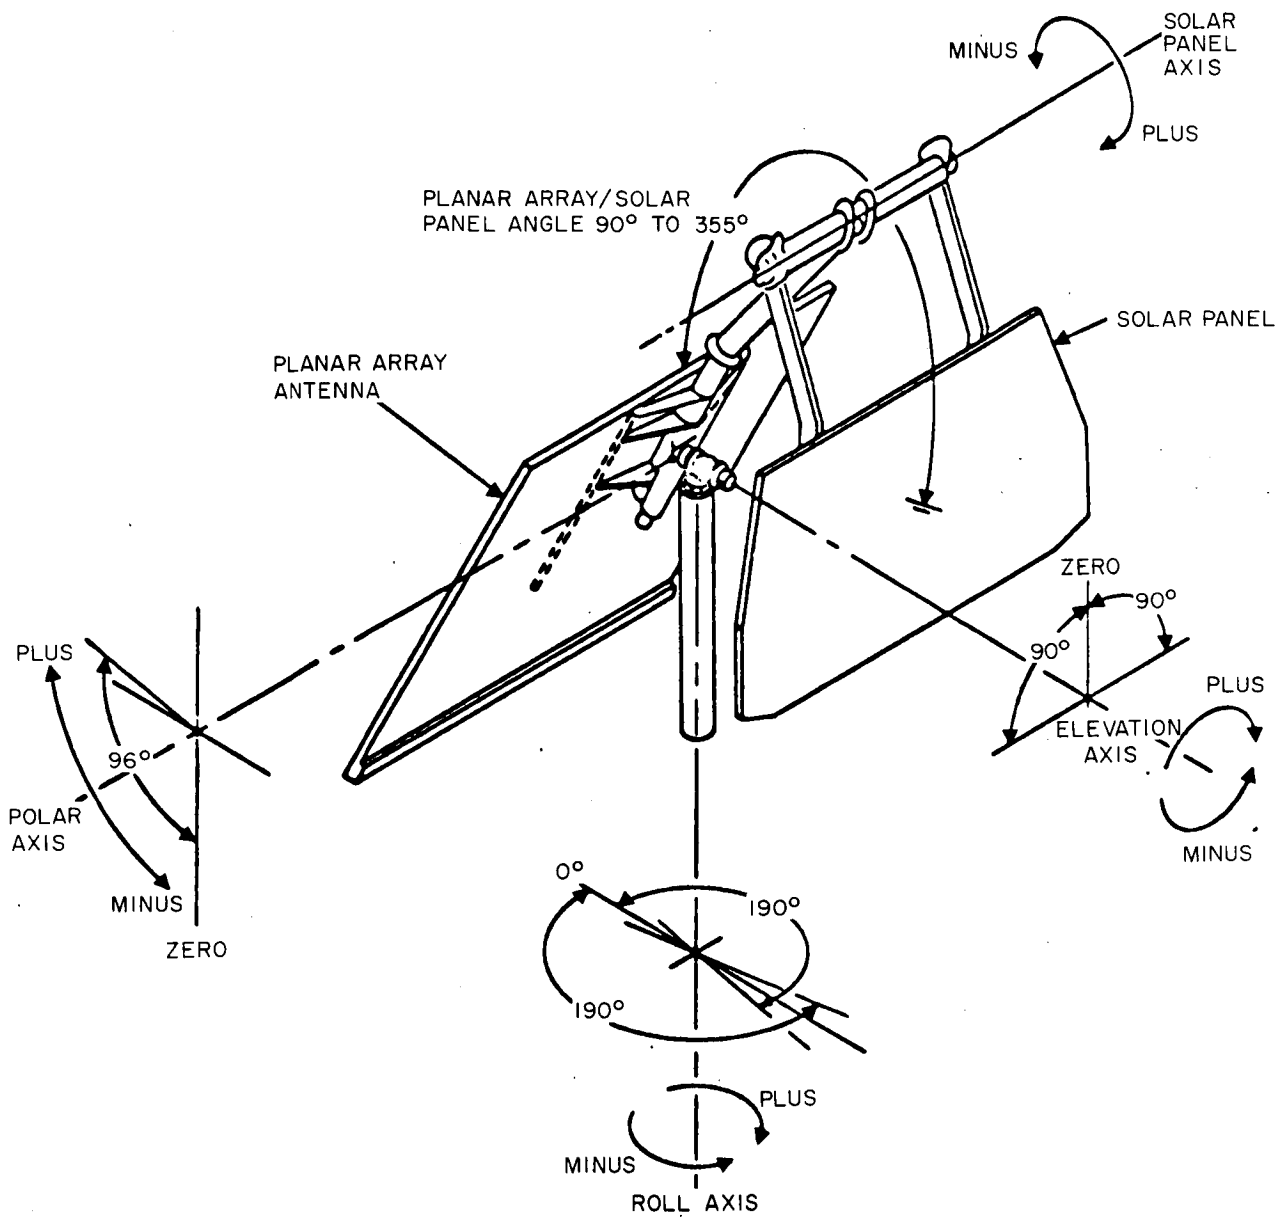
Figure 5.10-1. Antenna and Solar Panel Positioner

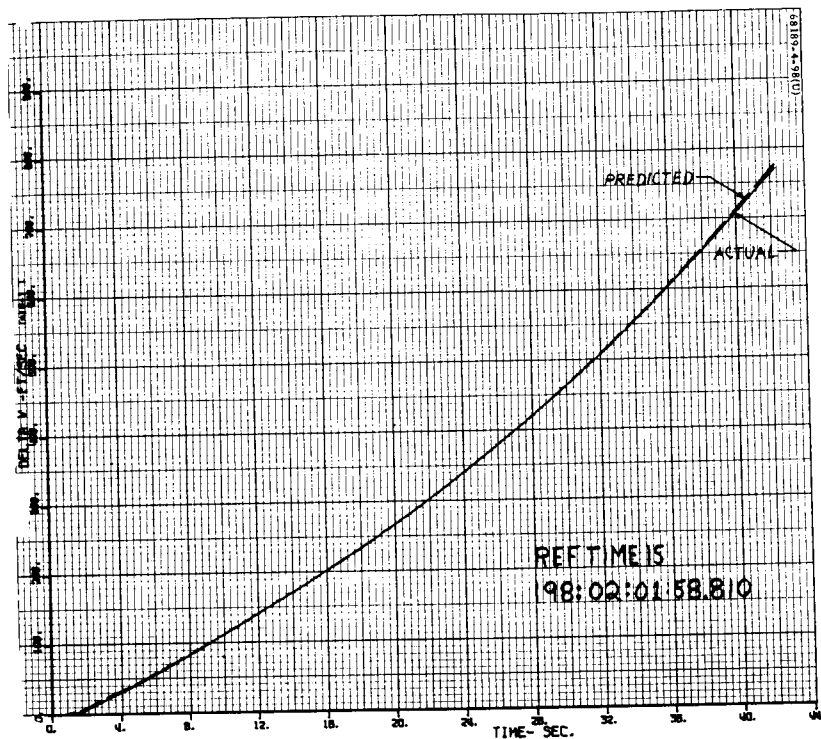
Figure 5.11-1 shows a comparison of actual and predicted Surveyor IV ΔV (retro plus verniers) versus time from vernier engine ignition to the time of signal loss. The ΔV during this phase is found by dividing the sum of the radial velocity change as determined from the doppler data and the gravity-induced velocity component in the same radial direction by the cosine of the angle between the tracking station-spacecraft line and the spacecraft thrust axis. A correction is made to the doppler data to account for the radial velocity change, ΔV_{ROT} , due to the earth's rotation. The thrust-induced velocity change, ΔV , can therefore be determined as follows:

Figure 5.11-1. Surveyor IV ΔV of Retro Plus Vernier Engines From Vernier Ignition to Loss of Signal

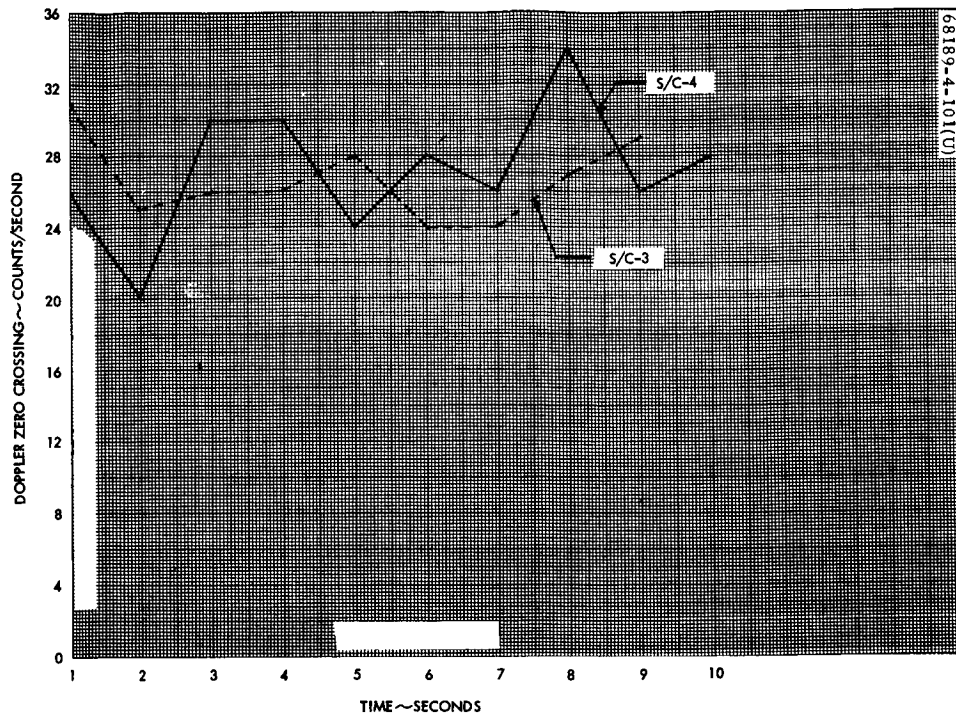
The unevenness in the Surveyor IV reconstruction is apparently caused by noise in the doppler data. Figure 5.11-4 shows a comparison of doppler noise levels for Surveyors III and IV for a 10-second period prior to retro ignition. The data shown here are available every second and are doppler count data which represent twice the frequency shift measured by the tracking station. These data prior to ignition represent the spacecraft velocity change caused by lunar gravity and would appear as smooth straight lines if no noise existed. It can be seen that the Surveyor IV data are noisier than the Surveyor III data.

Figure 5.11-4. Doppler Count Data 10 Seconds Prior to Retro Ignition

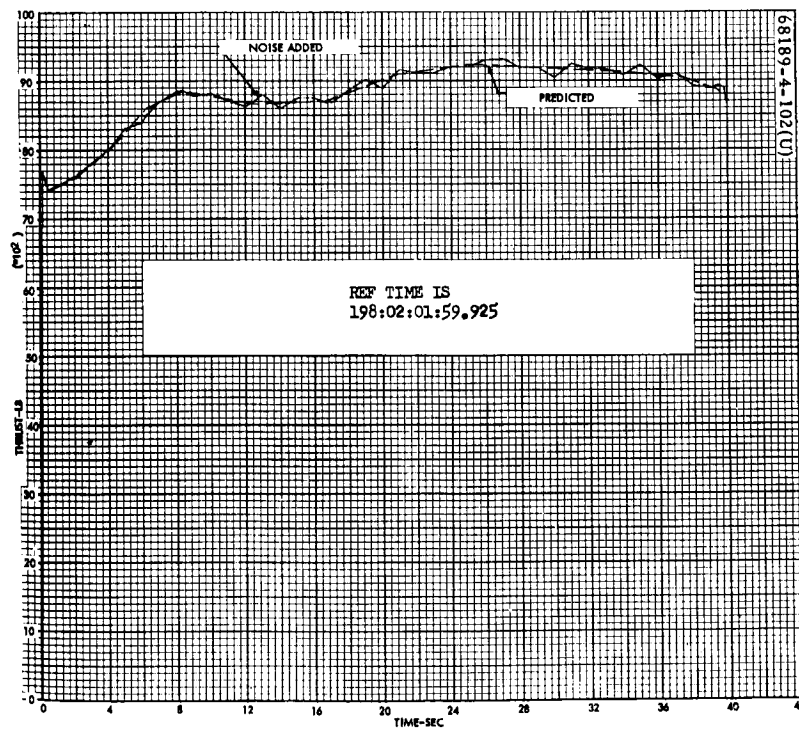
Figure 5.11-5. Surveyor IV Thrust Versus Time History – Predicted and With Preretro Doppler Noise Added
